FINAL REPORT
SEPTEMBER 1994

REPORT NO. EVT 18-90

155MM METAL FIELD ARTILLERY
PROJECTILE PALLET (FAPP)
FIRST ARTICLE TESTING (FAT)

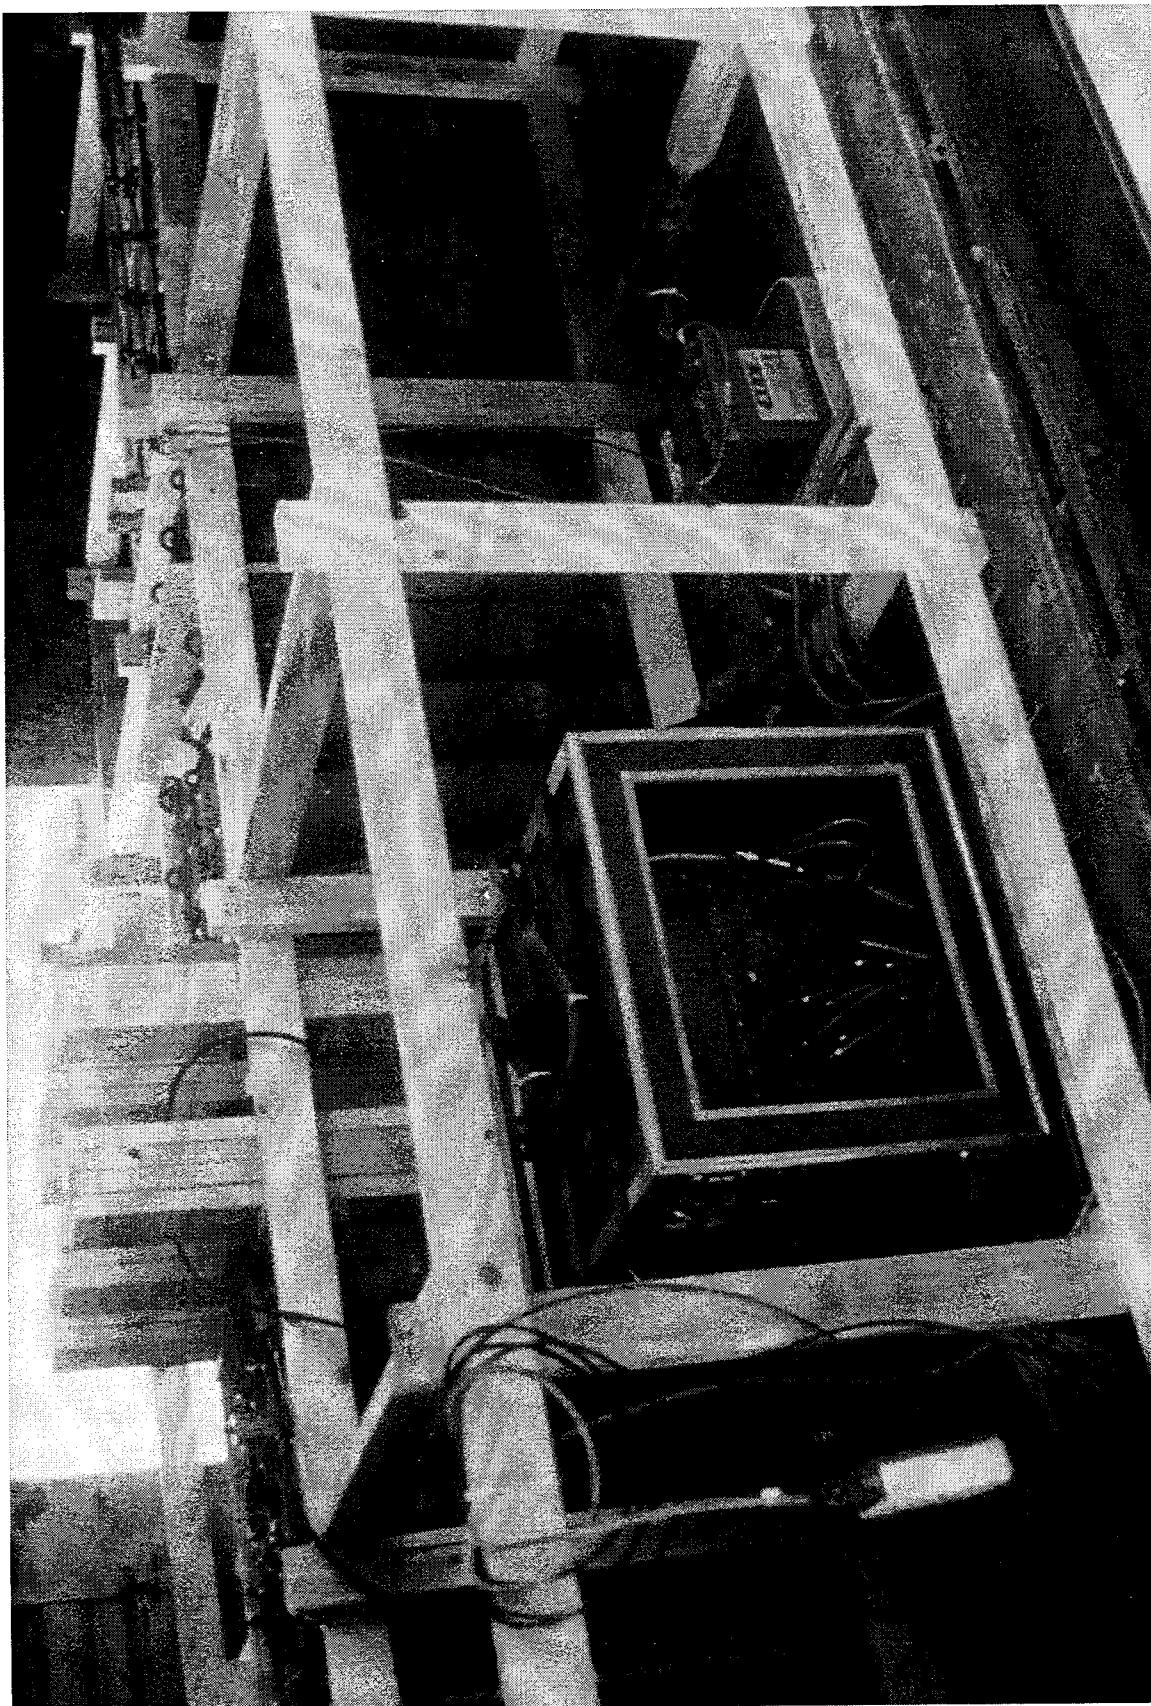
PHOTO NO. AO317-SCN94-257-5033: This photo shows the overall view of the test load. Note the three metal pallets are located at both ends of the railcar as well as six metal pallets located at the center of the test load.

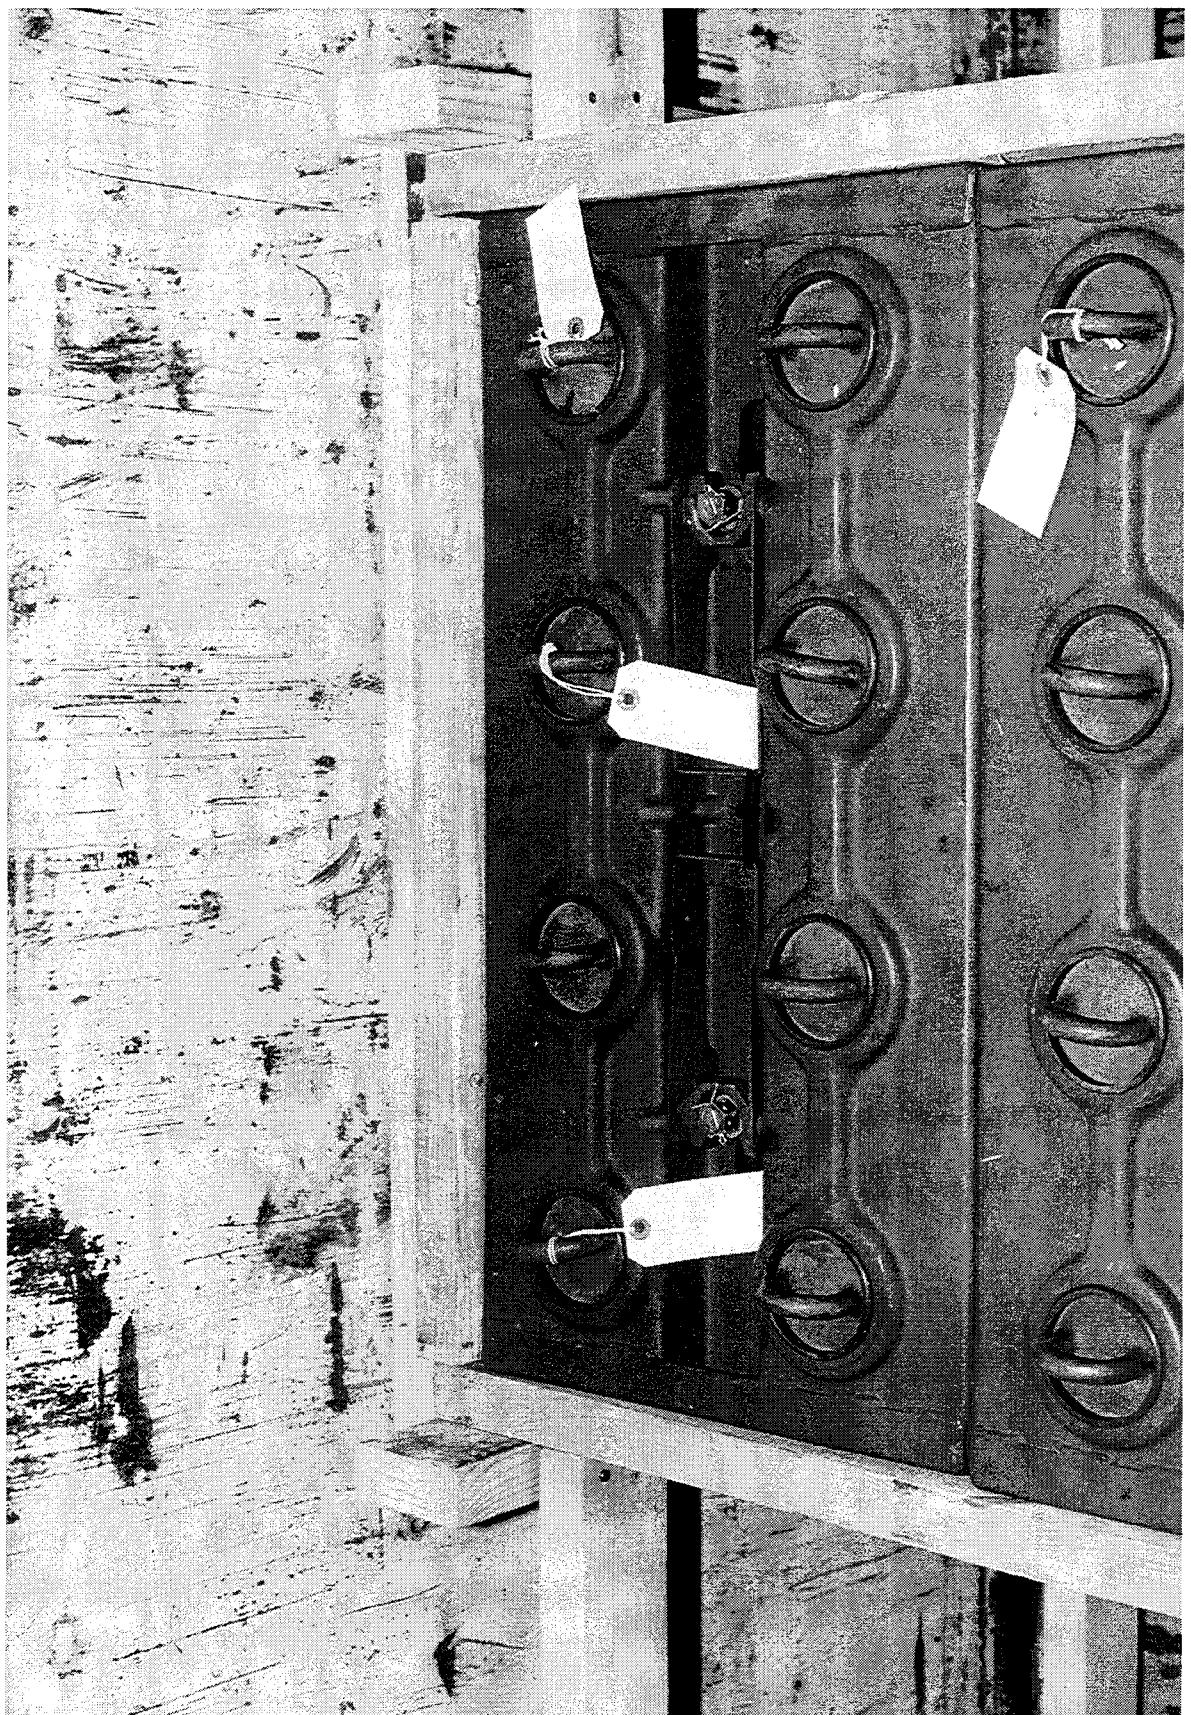
PHOTO NO. O317-SCN94-257-5036: This photo shows a closeup view of the high-speed data acquisition system used during rail impact testing. Note the accelerometers are located at both ends of the railcar as well as at the center. The load cells were also placed between the center gates to determine the load forces.

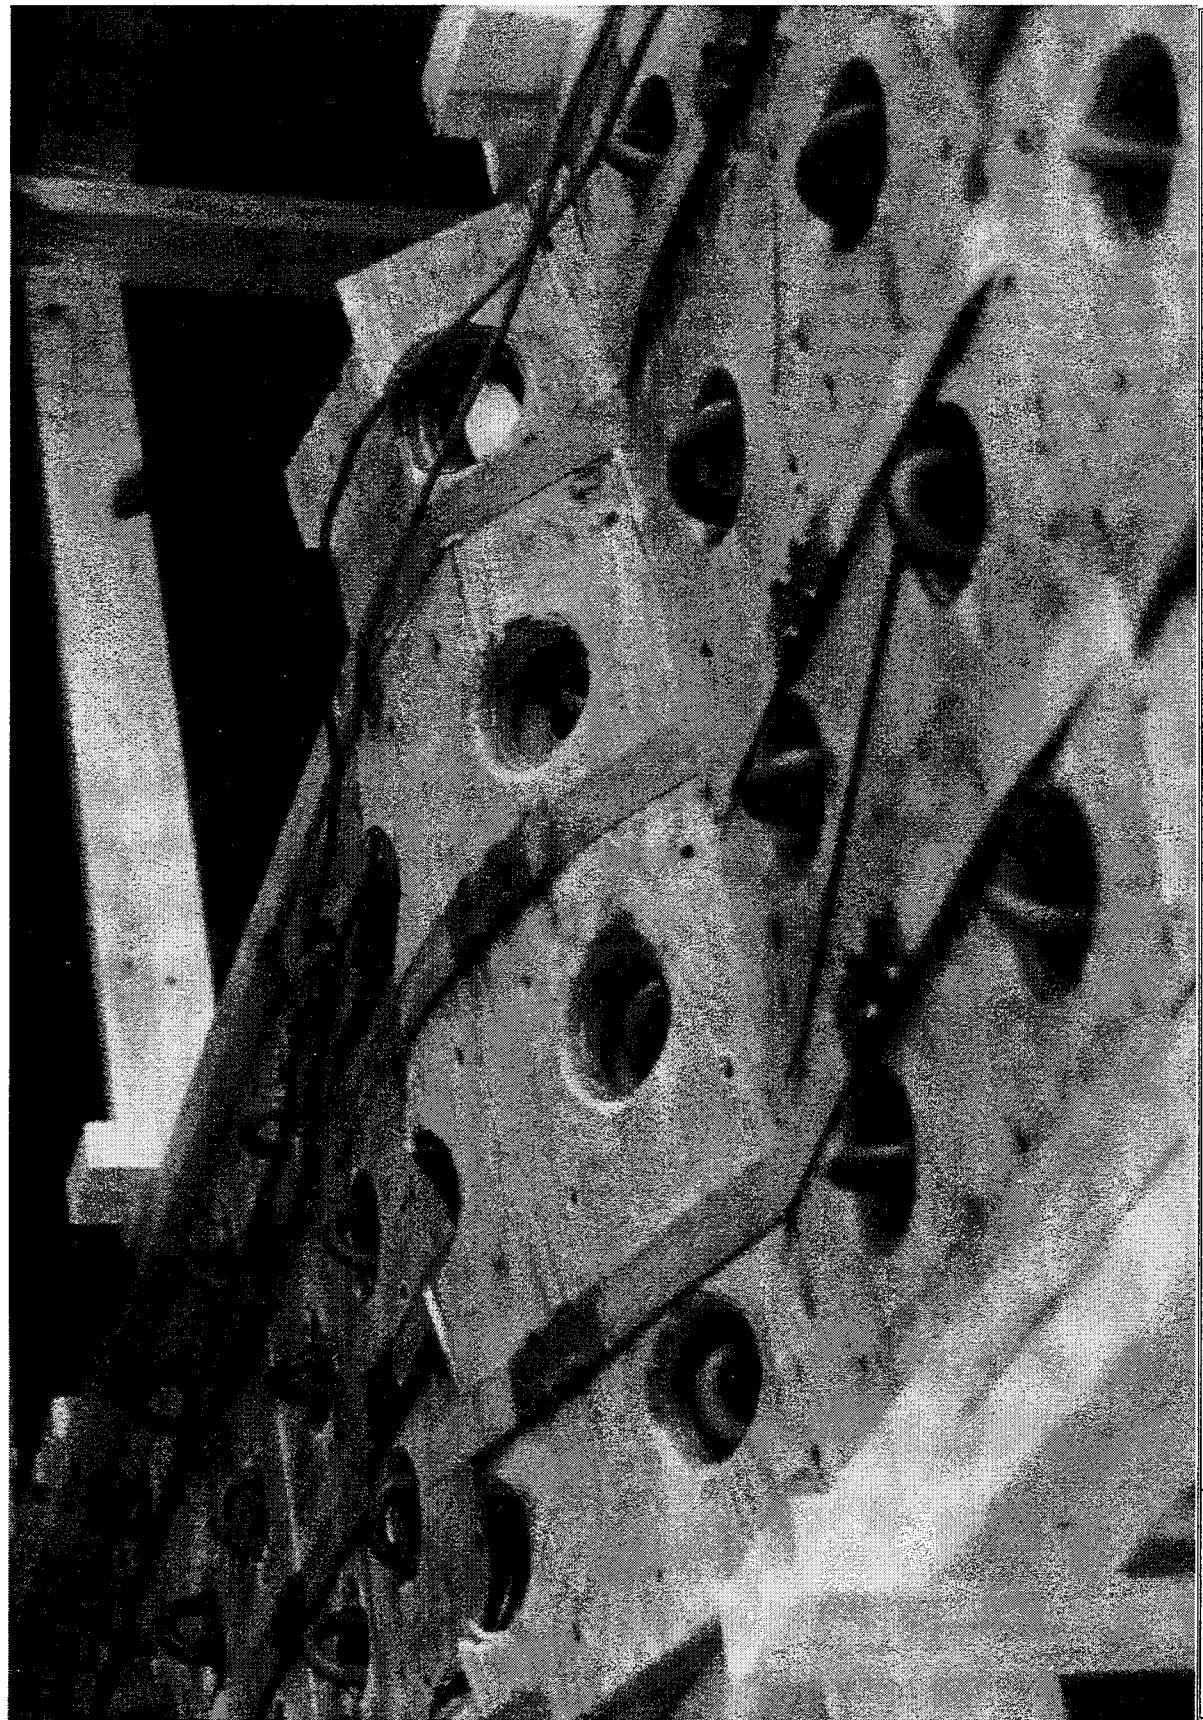
<p>U.S. ARMY DEFENSE AMMUNITION CENTER AND SCHOOL - SAVANNA, IL</p>
	<p>PHOTO NO. O317-SCN94-257-5039 This photo shows a closeup view of the inert-filled 155mm wooden pallets used to fill out the test load. Note that substantial damage occurred to the top pallet adapter following rail impact testing.</p>

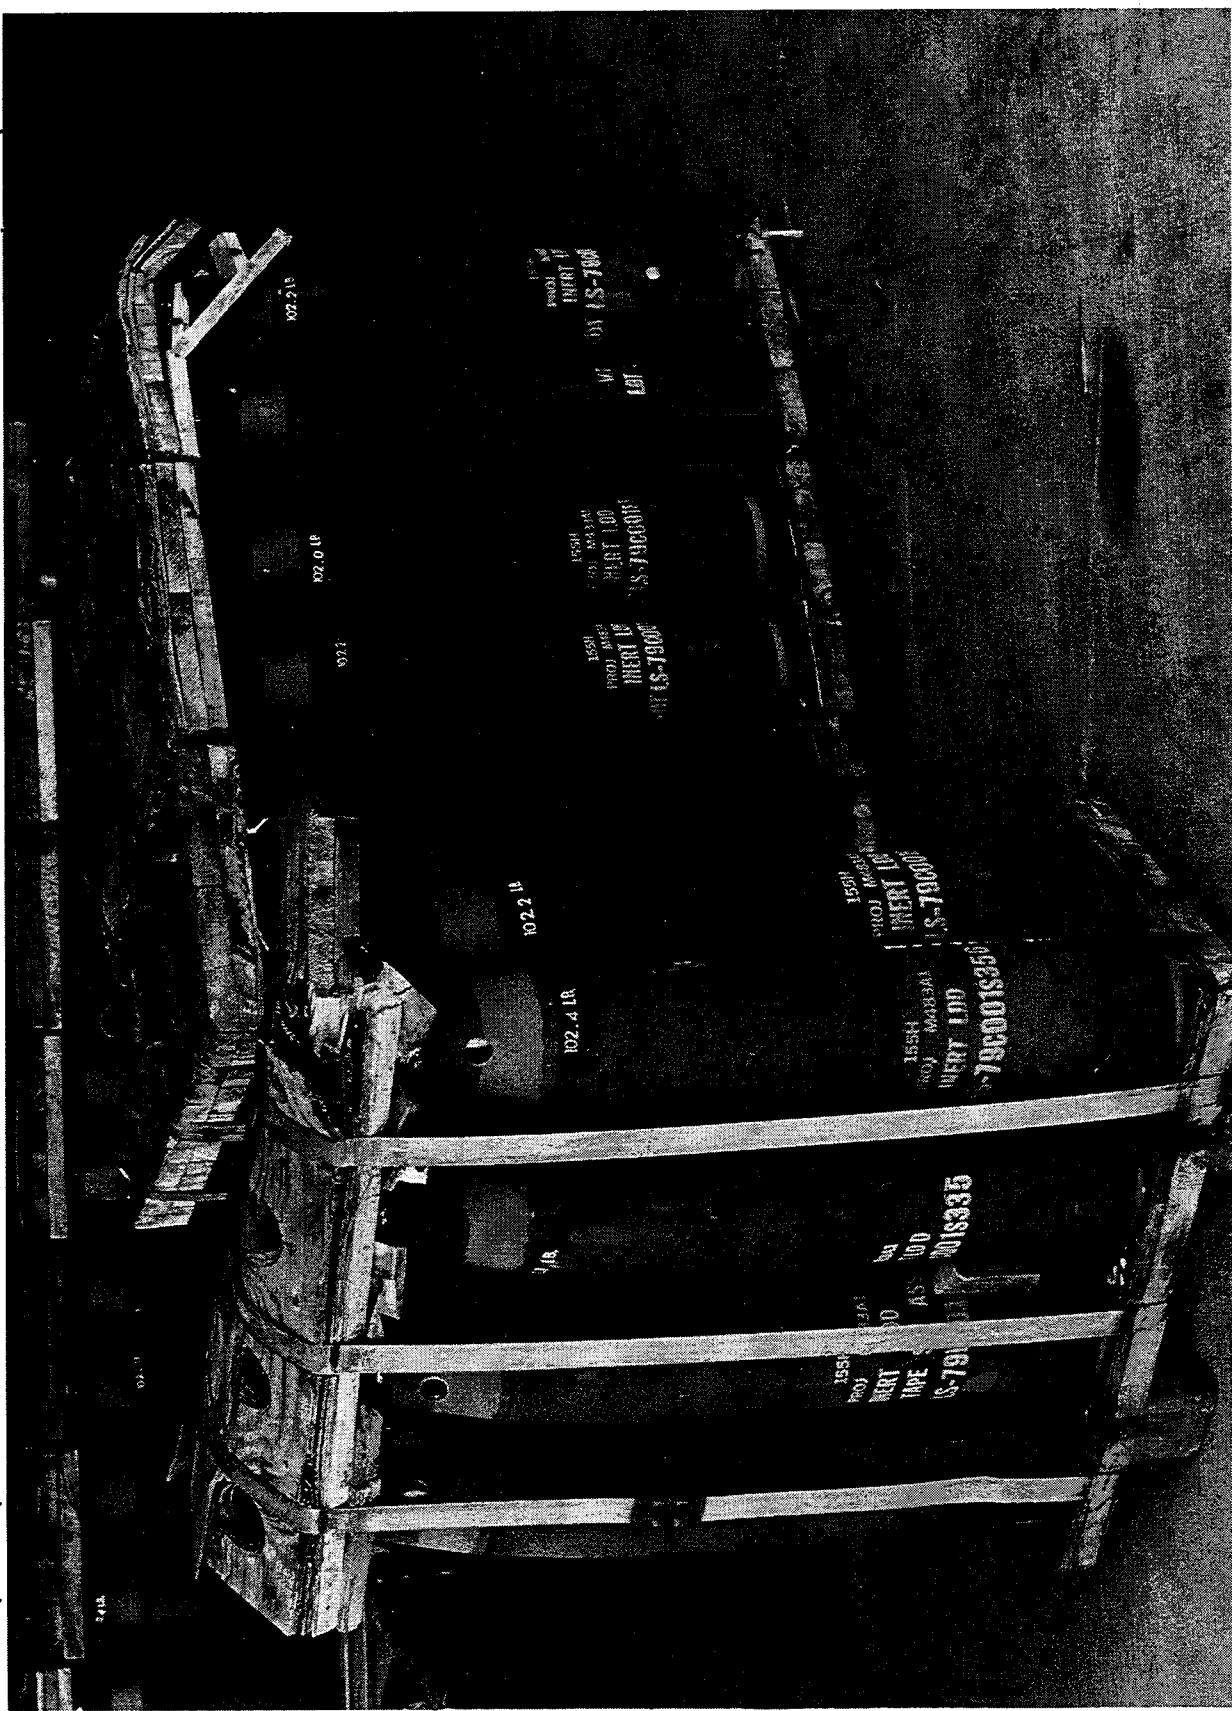
PHOTO NO. 0317-SCN94-222-4180: This photo shows a closeup view of the inert wooden pallets used during testing. Note the extreme damage which occurred to the wooden top pallet adapters.
